Manhole Inspection Summary

Manhole # S33WW1015MH

Insp Date: **1/24/07 2:28 PM**

Location Address: **5201 SPRINGLAKE WAY**

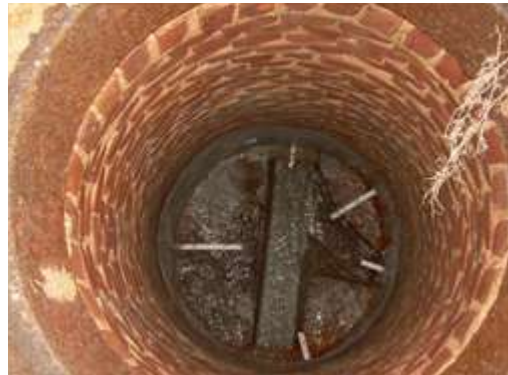
Top View

Barrel infiltration. Bench debris.

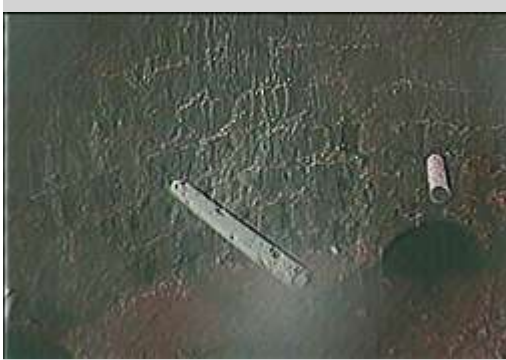
Defect

Barrel deterioration and infiltration.

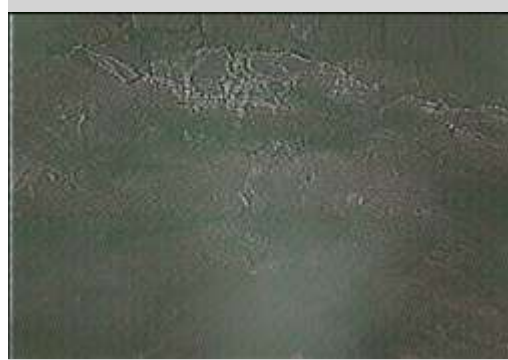
Defect

Barrel deterioration and infiltration.

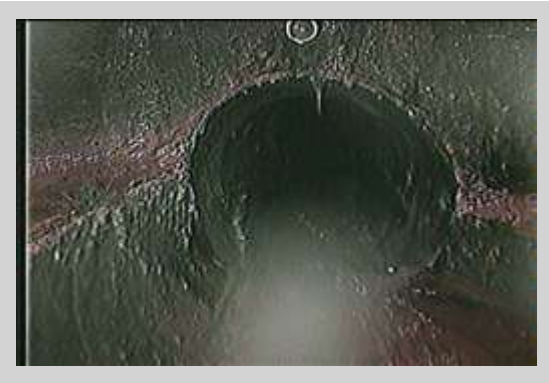
12 in. Circular Gravity Sewer Pipe Out @ 12 O'Clock

Infiltration: **None** Pipe Seal Cond: **Cracked**
